FINAL REPORT OF NONFATAL COAL-MINE BUMP ACCIDENT  
NO. D-1 MINE  
WISCONSIN STEEL COAL MINES  
INTERNATIONAL HARVESTER COMPANY  
BENHAM, HARLAN COUNTY, KENTUCKY

February 10, 1970

J. L. Gilley  
Mining Engineer

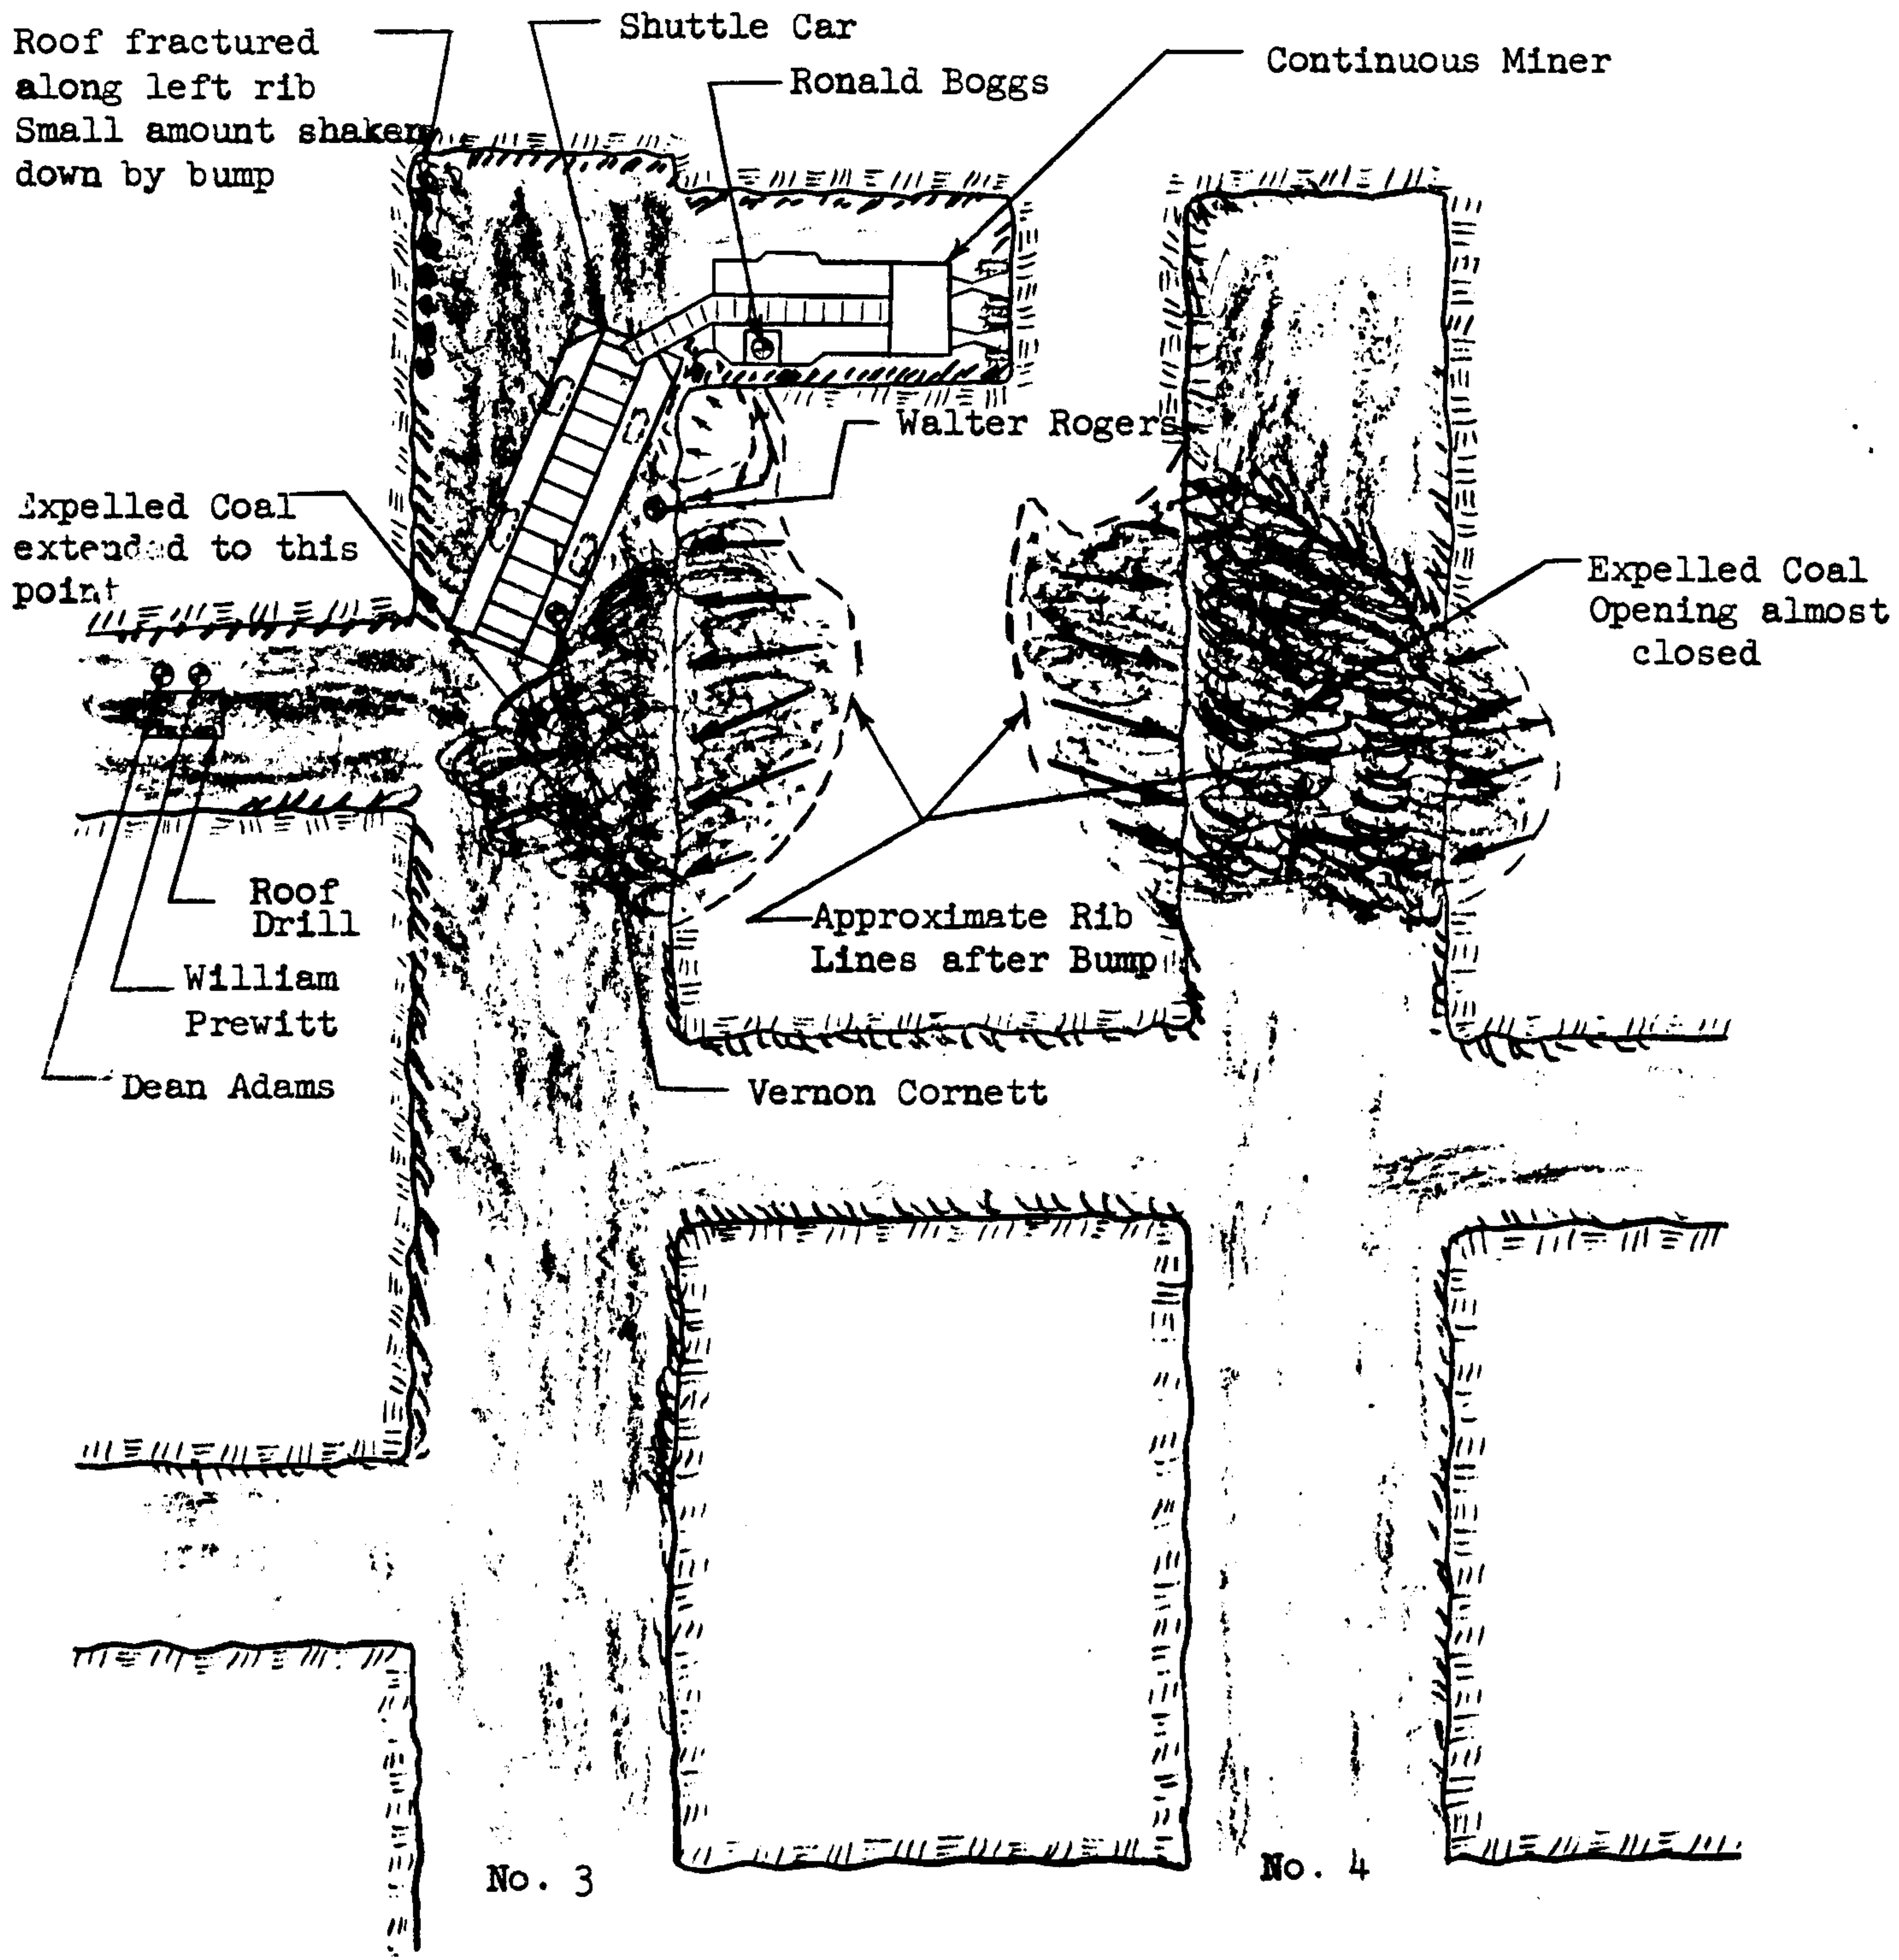
SKETCH NO. 1

The outburst was violent in nature in that a considerable amount of coal was expelled forcefully from 3 sides of the pillar between the Nos. 3 and 4 entries and from the adjacent ribs in the No. 4 entry, as indicated in Sketch No. 1. Voids 6 to 12 inches in height and extending as much as 15 feet over the pillars, were formed by displacement of the coal and the No. 4 entry roadway was nearly closed by pulverized coal. Coal also was shaken from ribs and face of the No. 3 entry and from the ribs of 4 pillars nearest the scene of the outburst. The reversal of strain or rebound in connection with the outburst fractured the roof at 3 locations, and pronounced heaving of floor and convergence occurred at the respective locations indicated in Sketch No. 2. A small section of roof was shaken down between the roof bolts and left rib near the face of No. 3 entry. Reportedly, the only damage to equipment was a broken hydraulic pressure-line connection on the continuous miner.

Location of men and equipment directly involved in the outburst and the extent of the outburst area are indicated in detail in Sketch No. 1. The active area, extent of development and correlation of the D-1 Mine entry development with the relative projections of large unmined pillars and mined areas in the subjacent "B" and "C" coalbeds are indicated in Sketch No. 2.

The areas of maximum disturbance encountered was in the vicinity of the accident; however, the line of disturbance was first encountered about 120 feet outby the face of the No. 3 entry and in the other entries at the general locations indicated in Sketch No. 2. The type of relative displacement entailed a gradual bending upward of the coalbed and adjacent strata, horizontally, rather than by abrupt vertical displacement. This bending action was accompanied by distinct induced fracturing of the roof

From the foregoing description of the relationship of overburden, interval and nature of overburden, and the proximity of the two underlying coalbeds, the outburst resulted from the additive effects of superimposed abutment loads too great for the main face entry pillars to withstand. The consequent distortion and the concentration (impingement) of stresses in the main face entry development are attributed to previous mining in the subjacent "B" and "C" coalbeds, especially the area in the "C" coalbed containing the large abandoned coal pillars underlying the recently acquired boundary of coal in the D-1 Mine workings. Other factors involved include: The course for the main face entries was projected on

1. The plans for current and future mining should take into consideration the degree to which the effects of previous mining in contiguous coalbeds will contribute to potential outbursts in the coalbed being worked, in this case the "D" coalbed.

2. The mining plans for the D-1 Mine should not incorporate areas in the subjacent "C" coalbed where, from past experience, manifestations indicate areas of high stress and distortion from processes of subsidence in the lower beds.

3. The mine maps of the vertically adjacent mine workings on this property or the maps of any workings in adjoining mines or any parts of the mines acquired for production of coal, should be accurate and up-to-date. Such maps should show all pillared, worked-out and abandoned areas, in the subjacent and in the superjacent coalbeds.

4. Every means should be taken to properly impress upon employees, the dangers of unnecessarily positioning themselves between the coal ribs and equipment especially in areas prone to outburst.
